**Measured System Performance  
and  
Diagnostic Testing  
Report**

***U.S. Air Force Academy, Colorado  
Commissary***

**Defense Commissary Agency (DeCA)**  
Directorate of Facilities  
Facilities and Programs Division  
Fort Lee, VA

U.S. Army Construction Engineering Research Laboratories  
Champaign, IL

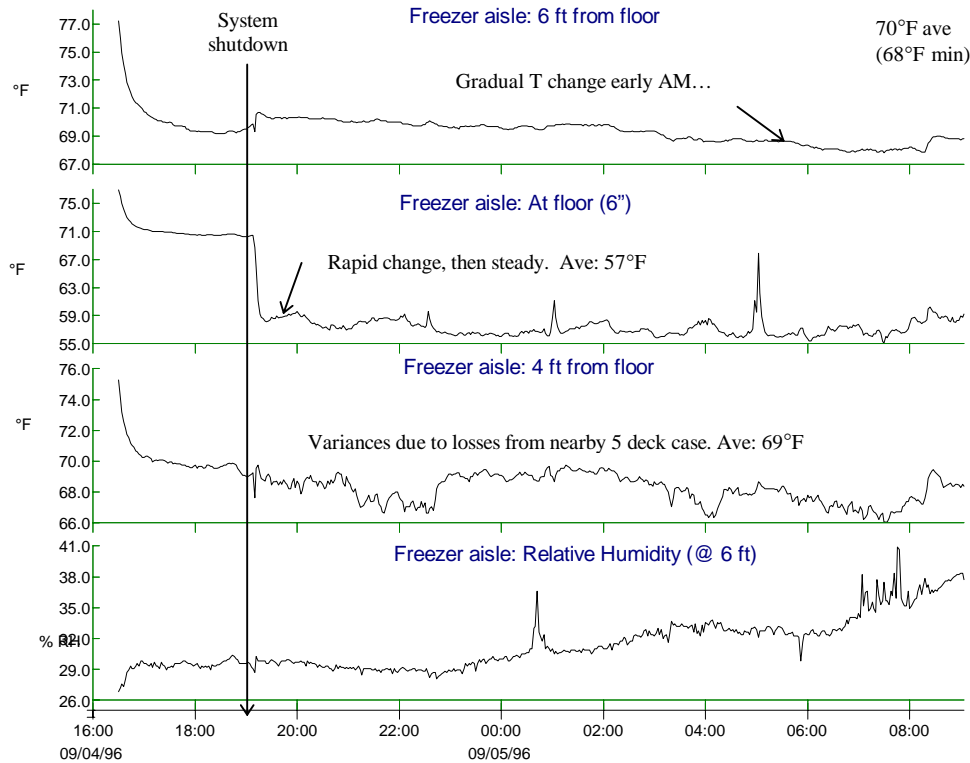
*Figure 4-2. Zone Temperature Results of Night Setback Experiment*

Also during the follow-up visit, an experiment was performed to determine the temperature stratification which would result if the supply air fan were turned off during store off-hours. The air handling system was shut down at 1800 hrs on Sep 4 and reactivated 13 hours later at 0730 hrs on Sep 5. Temperature and humidity were measured in the zone in both the dry grocery and in the cold section, as well as at outdoor ambient and supply and return duct locations. Results of zone temperatures are shown in Figure 4-2. A slight stratification between dry and cold areas set up rather quickly until a new equilibrium condition was reached. Contributing to comfort conditions overnight was the absence of cool outside air into the store, which would need to be heated during a typical night operational mode. Discussions with night personnel indicated that nobody noticed any change in space conditions overnight. A sharper temperature stratification

was also observed to set up vertically at the cold aisle temperature/humidity station. This lower temperature near the floor (about 57°F at 6 in. above floor level) could cause discomfort for overnight stocking personnel only if they were to insist on wearing shorts or sandals while they work.

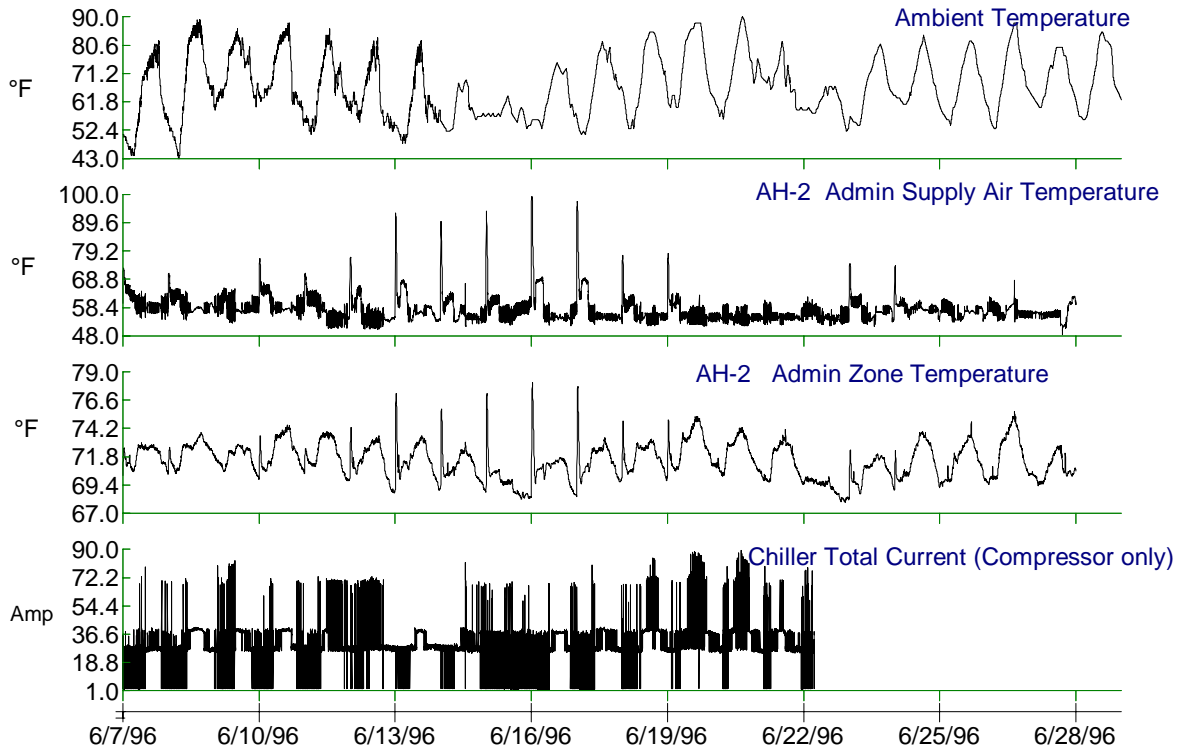
Figure 4-3. Overview of Admin Zone Performance versus Time

AHU-2 Observed System Performance: Figure 4-3 provides a time series overview of the admin zone performance. The supply air fan (not shown) ran continuously throughout the period and was set to ‘hand’ operation. With a fixed 25% OA fraction, this continuous air stream requires conditioning at almost all times. Temperature histories in the zone during the June period (using return air) show interior temperatures ‘profile-tracking’ OA, with zone temperatures exceeding 74°F as OA exceeds about 85°F (see Figure C.4-1 through C.2-4). A more typical setpoint-deadbanded variance is not visible for this zone. There are two possible reasons for this behavior; either (i) the return air is not a good surrogate for zone temperatures (due to stratification), or (ii) there is a problem with control of the chilled water valve at the AH-2 coil or there is insufficient flow at that coil. Stratification may be the cause, but this issue should be investigated further since discussion with the management and office staff revealed some historical degree of dissatisfaction with the control of temperature in this zone, particularly in summer months. One intermittent anomaly can be seen in Figure 4-3 shortly after midnight each day for about one week (6/13 to 6/19). The supply air temperature would increase to about 100°F (corresponding zone temperatures reached over 78°F) for about 30 minutes. The zone would regain its setpoint by 0100 hrs. No reason for this behavior was apparent, although a night setback thermostat located in the zone is suspect.

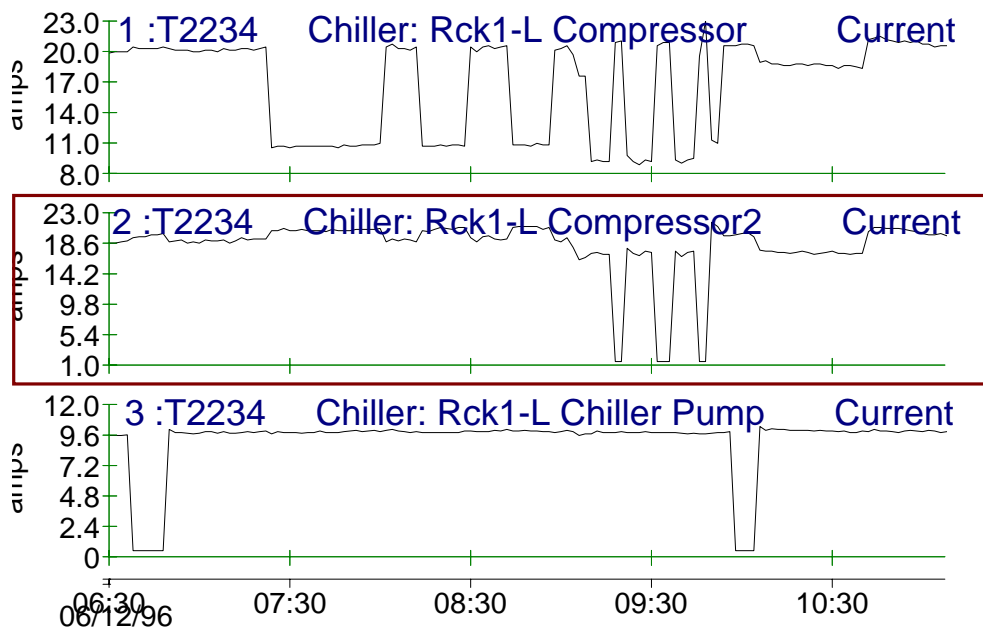
*Figure 4-5. Acceptable compressor performance - load increasing from 0800 to 1030 (note compressor ‘swapping’ at 0930)*

Figure 4-5 below illustrates a slight but acceptable instability from one load state at 0730 through an unstable period from 0915 to 1000, followed by stable load performance at 1030. Rack 1 serves the lowest temperature loads (ice cream and frozen foods) and uses a satellite compressor to lower the suction pressure for frozen foods to serve the lower temperature ice cream circuits. The top plot combines the energy use (amps @ 460V) of the first two compressors; the middle plot is the third compressor; the bottom is the fourth. In this case, the cycling occurs as a ‘swapping’ between compressors 2 and 3 to maintain a constant suction pressure in the common manifold.

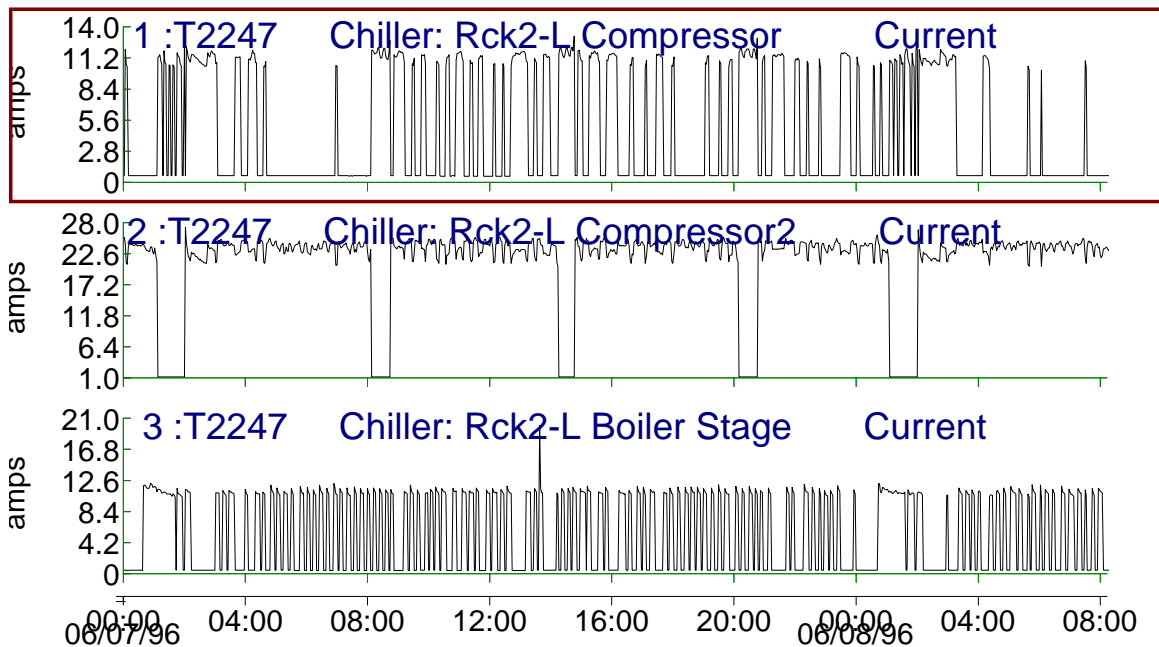
Figure 4-6. Rack 2 Compressor Current Profiles (note cycling of #1 and #3)

Figure 4-6 below illustrates a situation on Rack 2 where some changes to the suction pressure setpoint (SSP) or to the compressor control sequence may be warranted. This cycle (shown for the date 8 June 96) repeats daily for the entire 3-week period. The first

three plots illustrate behavior of Compressors 1, 2, and 3 respectively (ignore labels to the contrary); the fourth is total rack amp draw (the sum of the first three plots). The cycling observed at compressor 3 is perhaps on the margin of acceptability, averaging between 4 to 5 cycles per hour, although it occurs steadily throughout the entire monitoring period. Overall, however, the rack could be considered rather unstable due to the fact that both compressors 1 and 3 are cycling, exhibiting a somewhat choppy behavior. A better compressor sequencing strategy or suction pressure setpoint modification should be able to smooth out this power signature. Also, it is possible that a solenoid valve is leaky, allowing refrigerant into the manifold that needs to be pumped out. Discussion with a Scott-Polar technician indicated that they would see these problems only after they have caused some alarm-setting type event, and even then may not know the root cause of the problem.
